**Subject: Voluntary Emissions Recall Report for Customer Support Program (CSP) 20TE10
Certain 2013-2015 Model Year Prius and 2014-2017 Model Year Prius V Extension of Coverage to
the Intelligent Power Module (IPM) and CARB Approval Letter #F-2020-085 dated October 1, 2020**

***Re: Submission of Emissions Defect Information Report for Certain 2013-2015 Model Year (MY)
Toyota Prius vehicles and 2014-2017MY Toyota Prius V vehicles Inverter***

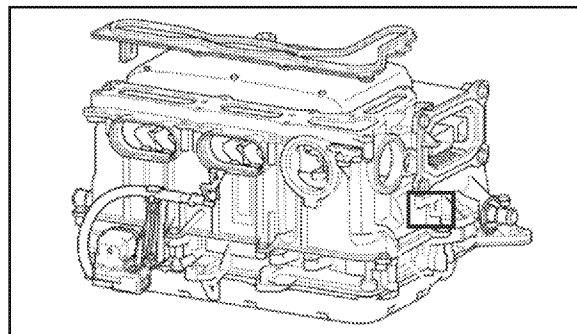
Figure 1.

MIL ON With DTCs P0A94, P324E, P0A1A, and/or P3004

1. Confirm the condition exists.
 - A. Are DTCs P0A94, P324E, P0A1A, and/or P3004 stored?
 - **YES** — Continue to sub step B.
 - **NO** — This bulletin does NOT apply. Continue diagnosis using the applicable Repair Manual.
 - B. Does the vehicle exhibit physical damage to the inverter assembly with converter in the location shown?
 - **YES** — Continue to step 2.
 - **NO** — Go to step 3.
